Running Out of Film While Printing

Overview:

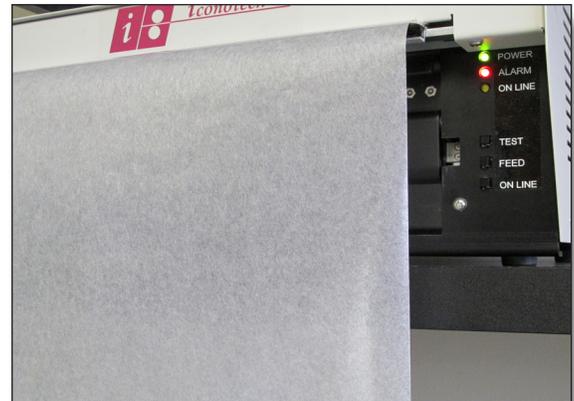
When the imager runs out of film in the middle of a print job, a red light alarm condition will occur along with a chattering noise. (Fig. 1) This tutorial will show you how to fix this condition.

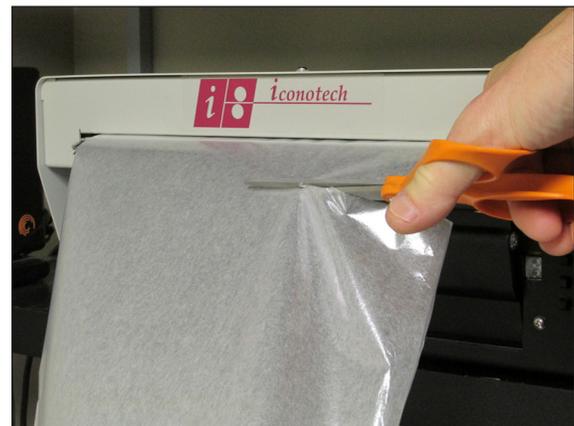
1. Begin by cutting off the excess stencil hanging out of the imager. (Fig. 2)

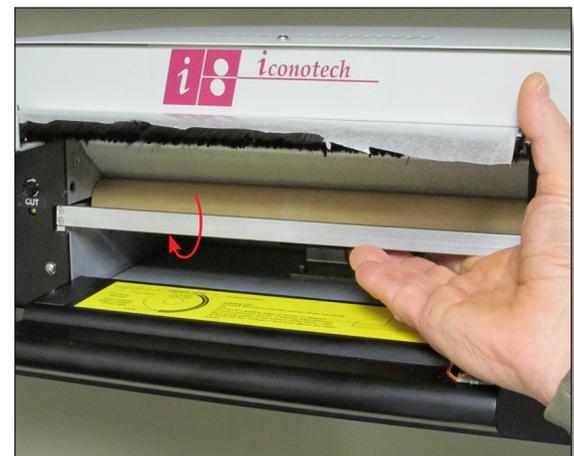
2. Rotate the core from the bottom clockwise to retract the remaining stencil back onto the core. (Fig. 3)

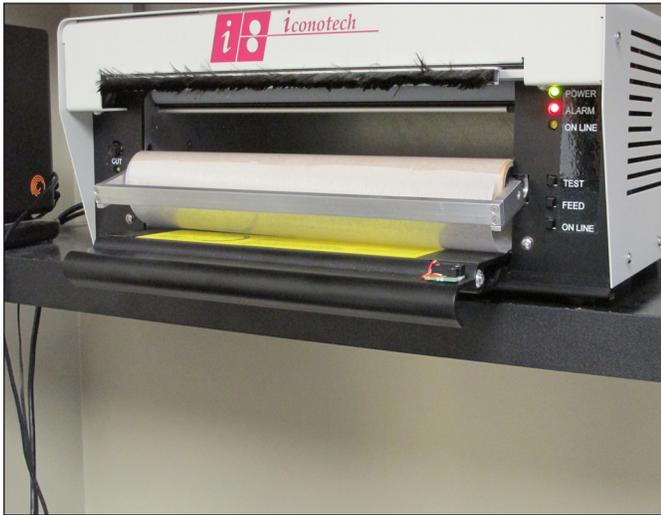
3. Remove the stencil core and media carrier, (Fig. 4) and load a new roll of film into the imager and close the door. The imager will start immediately and continue where it left off, processing the rest of the original print job. Once complete, discard the partial stencil and resend your print job to the imager to create a complete stencil.

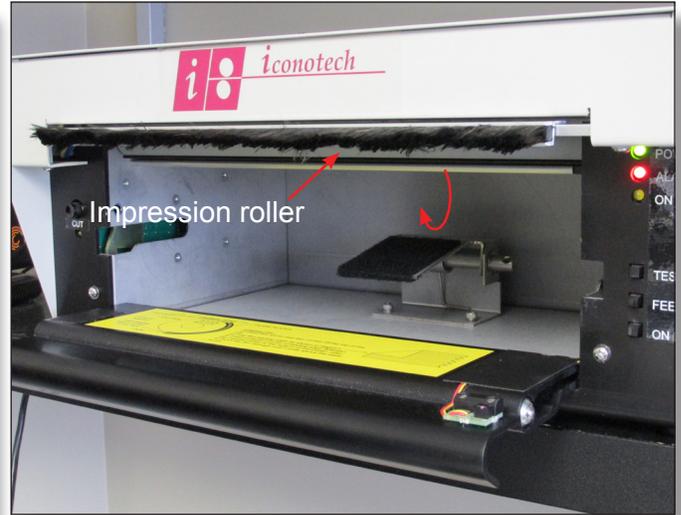
In really rare cases, the tape can stick to the impression roller, which can be either orange or grey. Using your fingers, rotate the impression roller, (Fig. 5) from the bottom clockwise until you see the tape. Tear the tape off of the stencil and pull the stencil back through the imager. Carefully remove the tape from the impression roller and remove any residual adhesive with a q-tip and isopropyl alcohol.
